Blade Inspection and Repair

Presenter: Theodoros Kossivas

MSc, Mechanical & Aeronautical Engineer, CompBlades founder

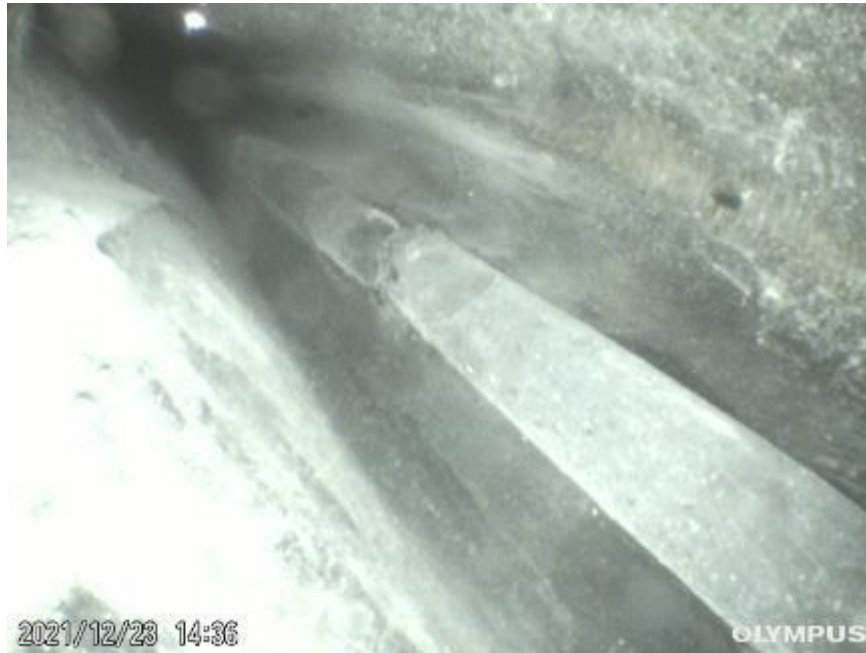
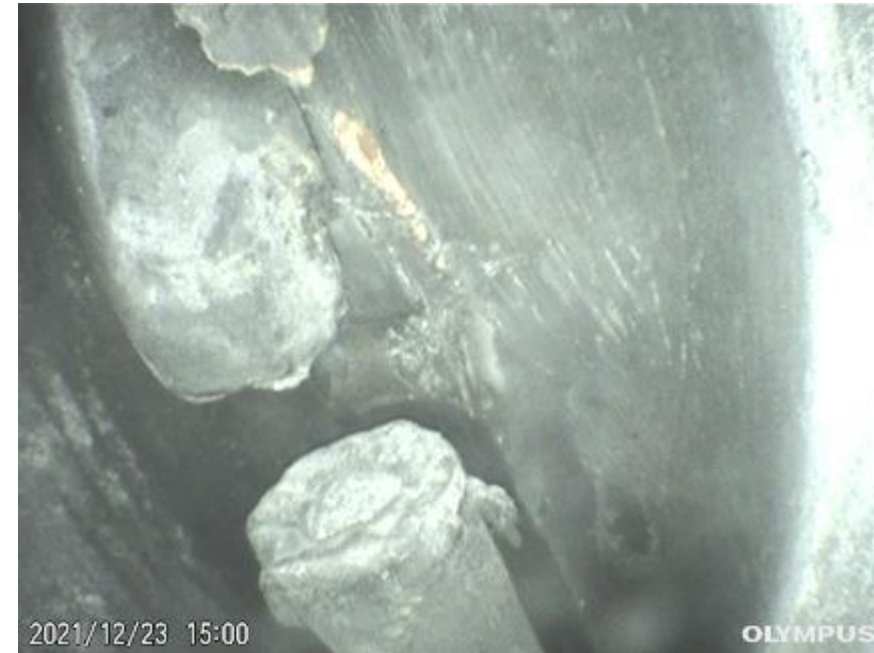
Internal inspection via Endoscope – Broken conductor rod (cable) of Lightning Protection System (LPS of the blade)

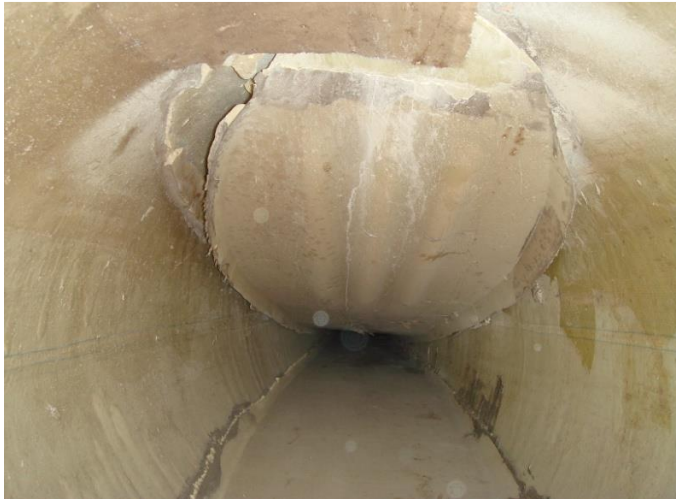
Shear webs were debonded (16m) along the blade skins. Blade was repaired and was in service from 2005 till 2010 (repower).

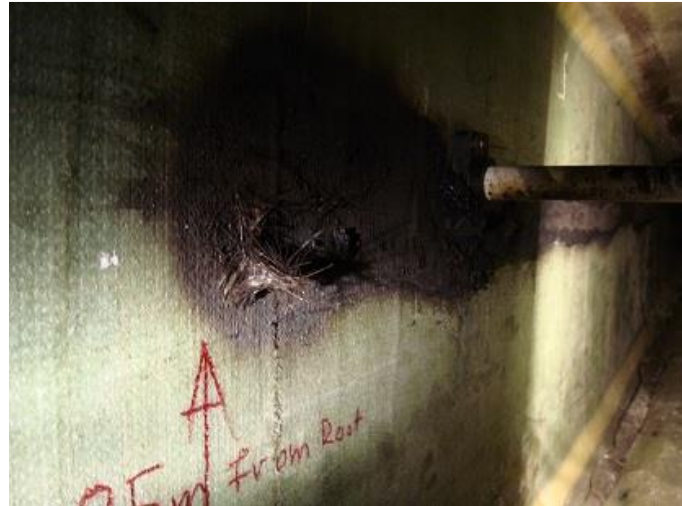
Burnt shear web from lightning and plastic tubular steel-rope container. Shear web was repaired, and plastic tube was replaced

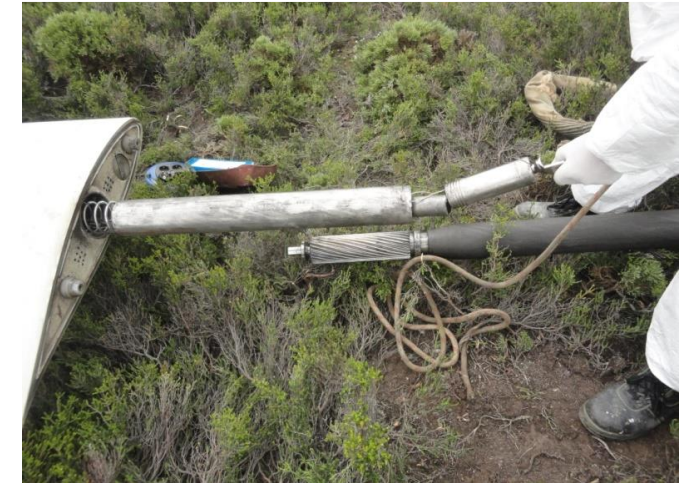
LM 19.1: Broken tube of the blade tip mechanism. A hole is opened on the spar cap to fix the spring end and reconnect the tube for the wire

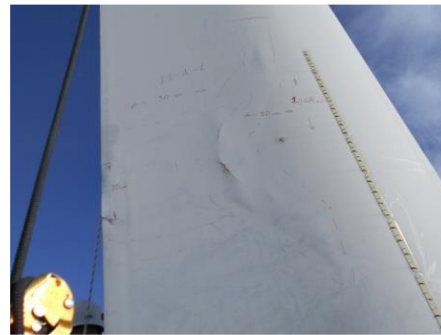
Suction side, 2m x 1m destroyed skin

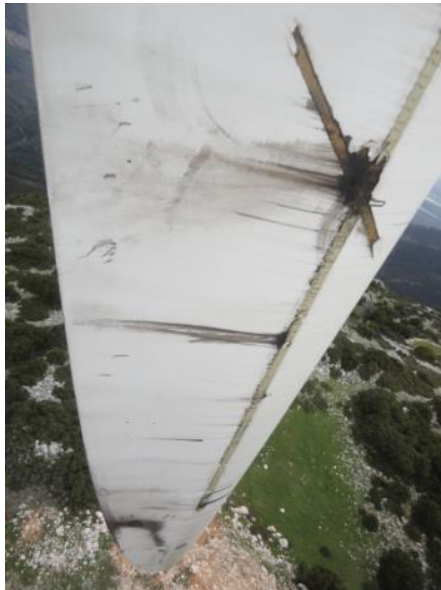
Lightning at spar cap

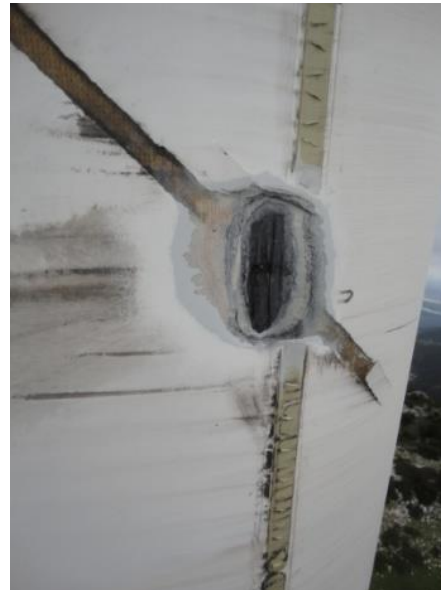
Damaged spar cap

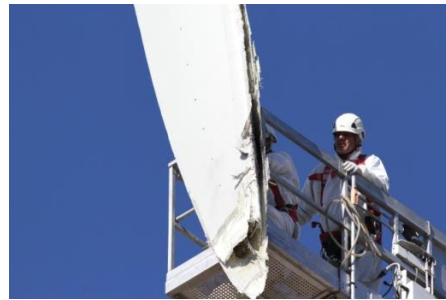
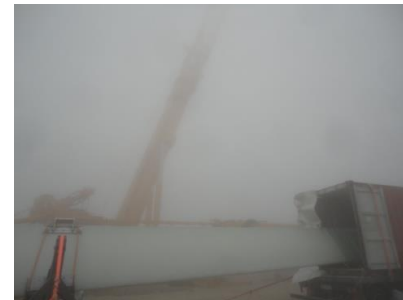
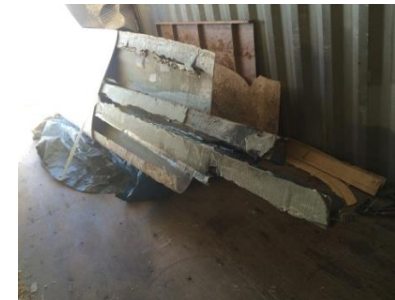
Blade repair at N90-2,5 MW. Destroyed 3,5m pressure side and 1,5m skin suction side and 5,9m debonding between shear webs and skins. Skin Reconstruction

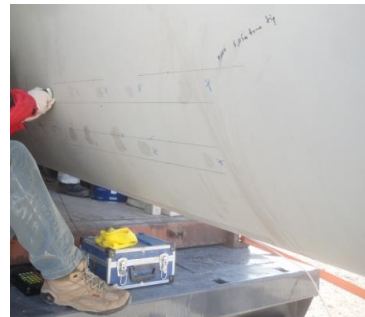
NDT inspection for deboning

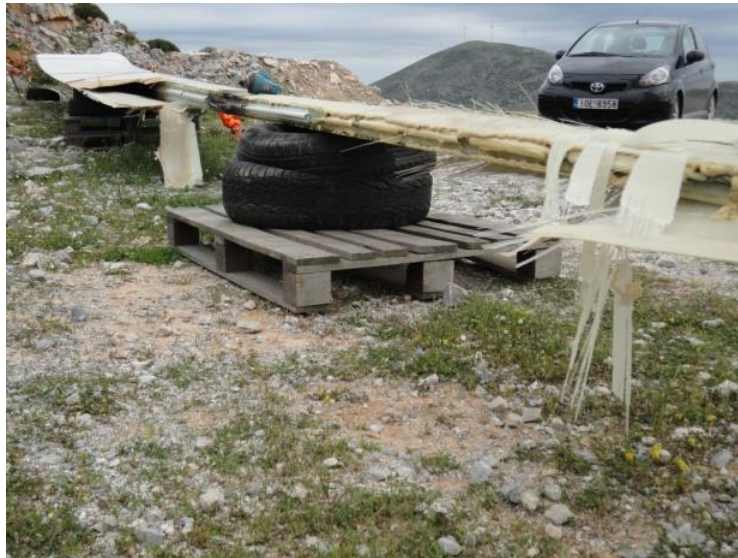
Before

10m repair on 23m blade keeping the balancing of the Reference rotor (2008)

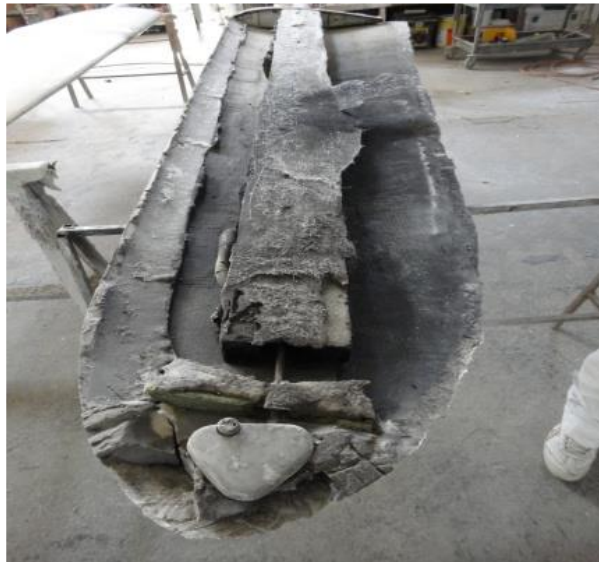
Burnt blade tip

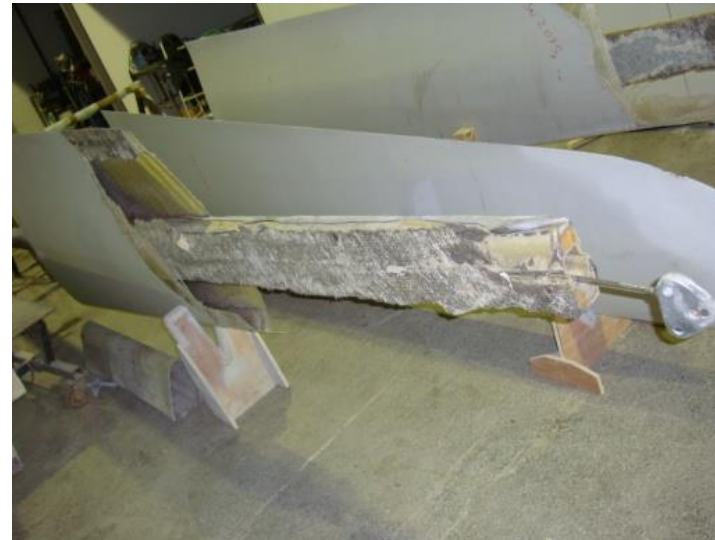
Destroyed blade tip

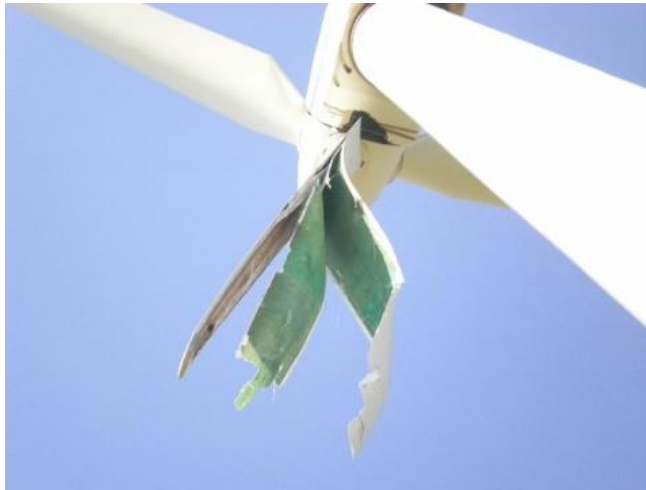
Destroyed blade

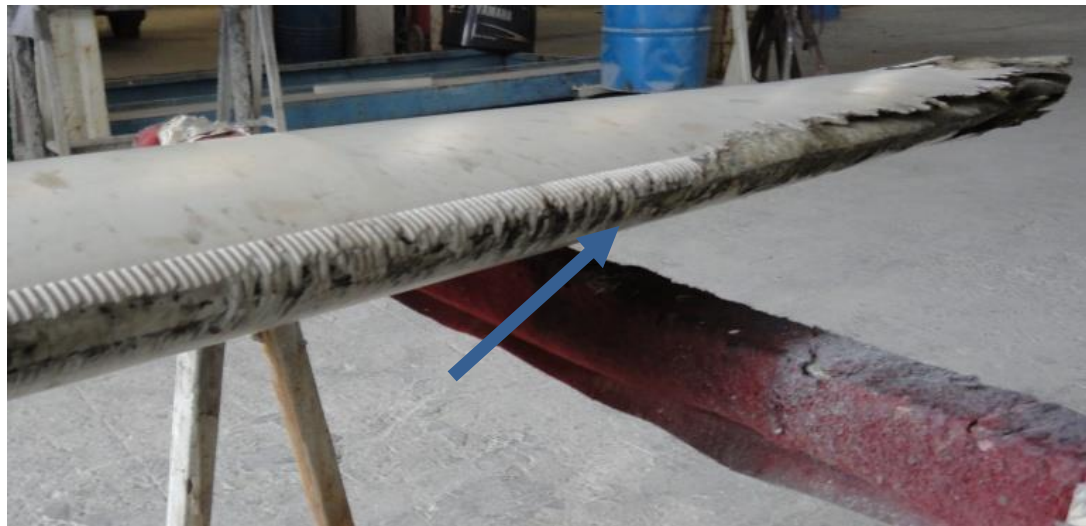
Eroded Blade tip leading edge and destroyed trip strips

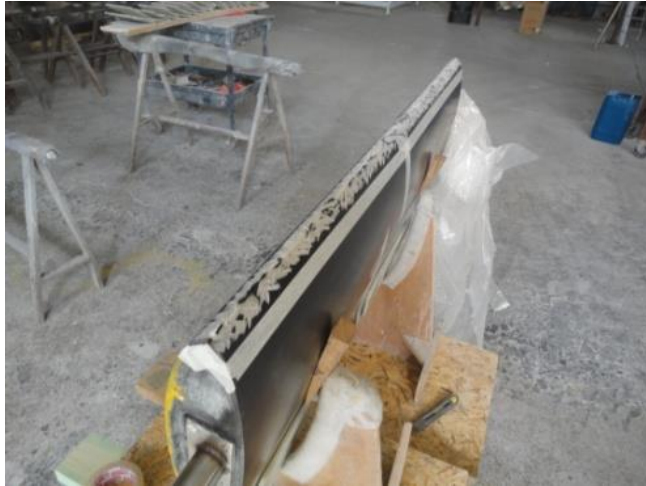
Destroyed leading edge

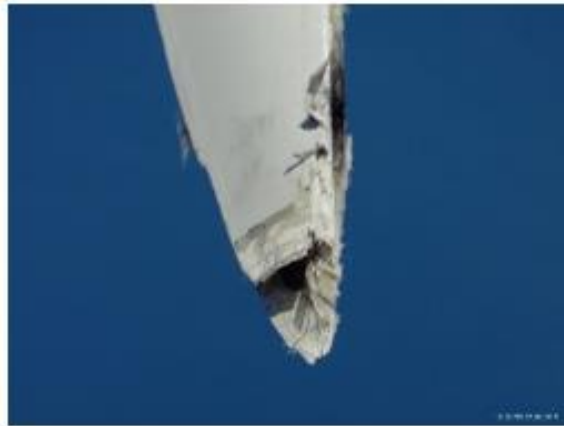
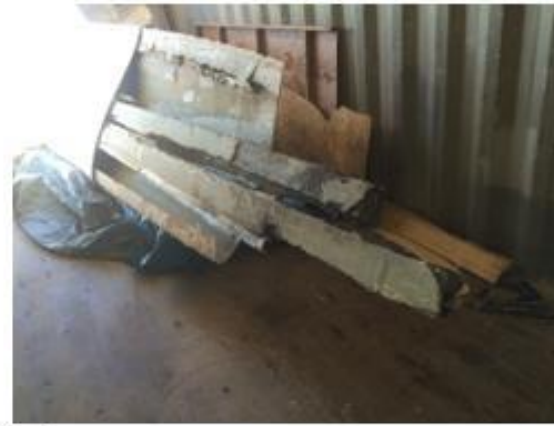
Destroyed blade tip
