Acoustic Emission 24/7/365 remote monitoring of W/Ts

Dr. Athanasios (Nassos) ANASTASOPOULOS

VP Sales & Engineering Mistras Group Hellas European Industrial Acoustic Emission Lead, Mistras Group Inc.

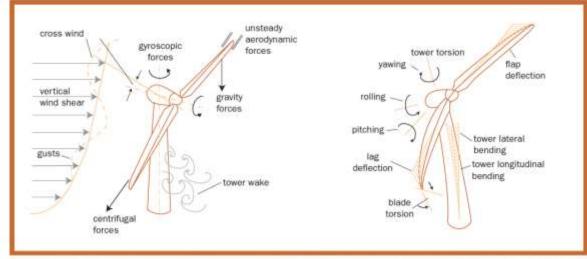
On the left all external dynamic forces are indicated that expose a turbine to extreme fatigue loading. On the right the various vibration and deflection modes of a wind turbine can be seen. From the dynamic point of view a wind turbine is a complex structure to design reliably for a given service life time.

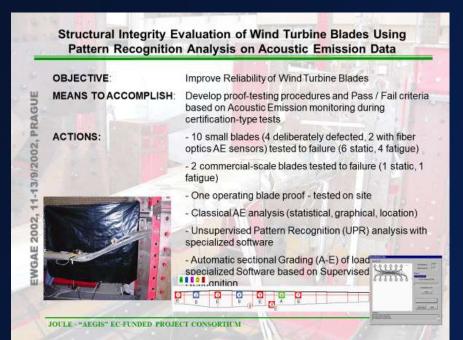
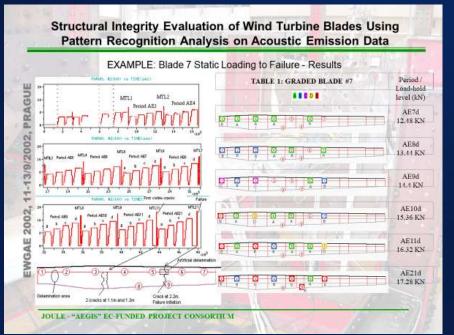
AE DURING LABORATORY FULL SCALE BLADE TESTING (DEVELOPMENT & CERTIFICATION - AEGIS)

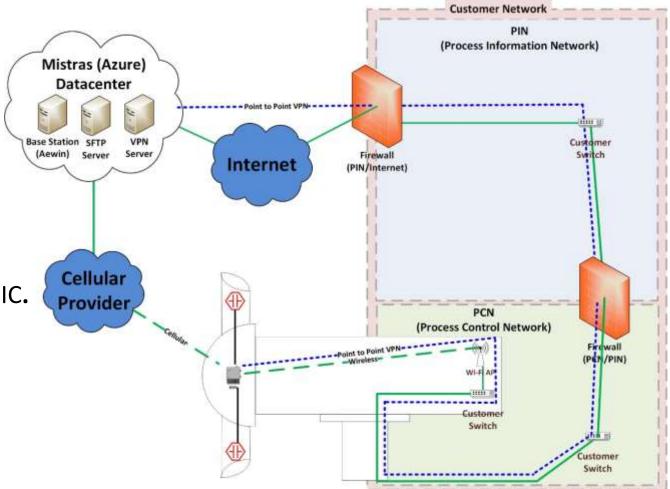
COMMUNICATION OPTIONS

- CELLULAR NETWORK
- WI-FI ACCESS POINT IN THE NACELLE
- SENSORIA CYBERSECURITY
 - ✓ Compliant with Standard IEC 62443.
 - ✓ DAQ protected by an integrated cybersecurity IC.

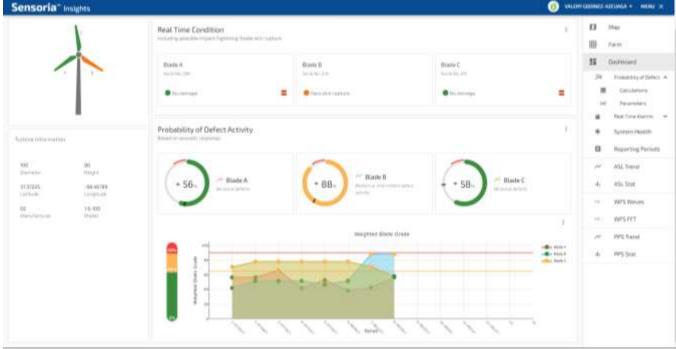
DATA-DRIVEN WEB APPLICATION

- Data-Driven web app provides a fleet wide, farm and specific asset view
- Periodic acoustic activity trend
- Historic blade grade calculations
- Real time asset status updated every 1.5hrs

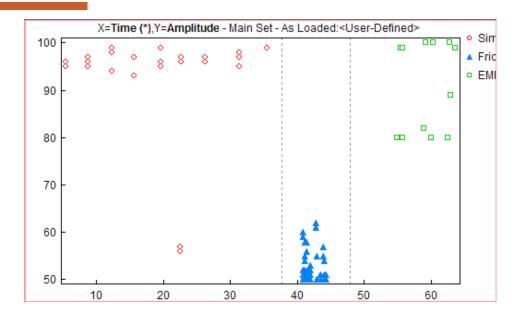
EXAMPLE of SPR using Artificial data

0 : Simulated AE (26.3 %)

▲ 1 : Friction (63.2 %)

2 : EMI (10.5 %)

- The data due to the experimental procedure are separated in time.
- Overlapping is evident in Amplitude and other features (see next slide summarizing measured features, waveforms->extracted features)

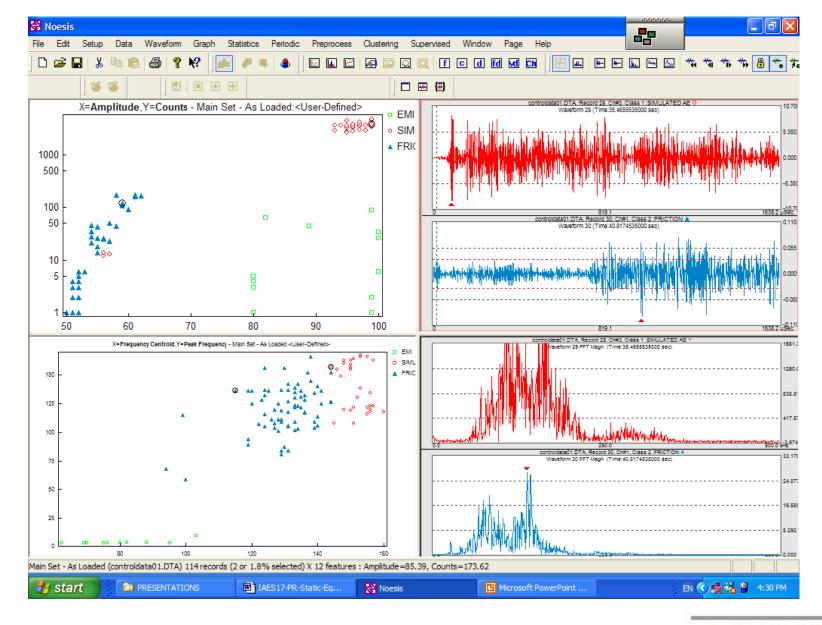
- Three MISTRAS-R15I sensors, mounted on a thick metallic plate in a triangular pattern (320mm X 540mm).
- •4ch MISTRAS AE unit was used for real time data acquisition and
- NOESIS pattern recognition s/w for the analysis and pattern s/w.
- AE signals produced by mechanical pencil lead breaks at various positions on the plate.
- Mechanical friction produced by sliding a small metal piece across the surface of the plate.
- (EMI) signals were generated by unplugging the sensor cable during acquisition.

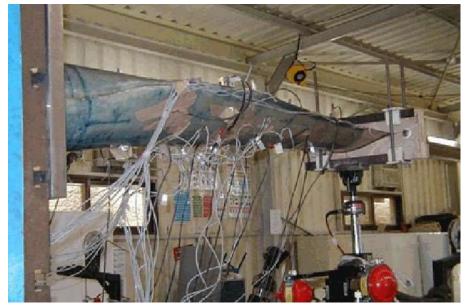
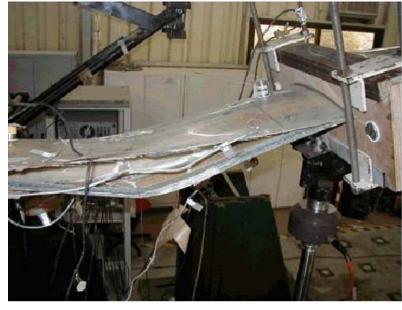
EXAMPLE: Blade 1 Static Loading to Failure – method calibration

Loading Envelope (to failure)

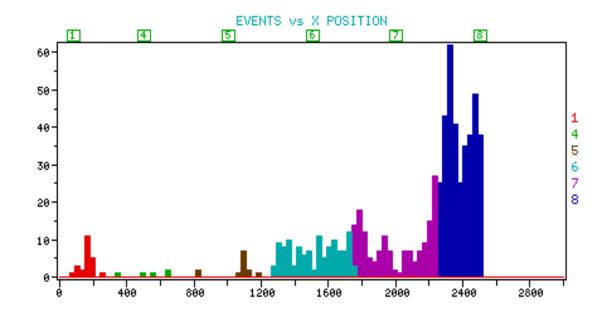
EXAMPLE: Blade 1 Static Loading to Failure - RESULTS

- Linear Location Results
- Automated Blade Grading Results (based on critical class)

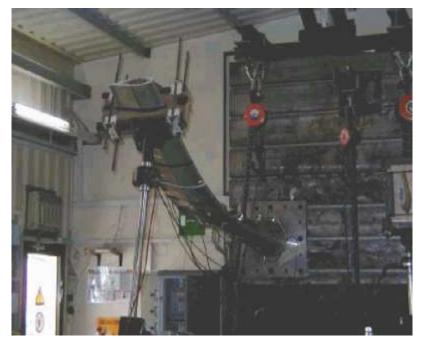
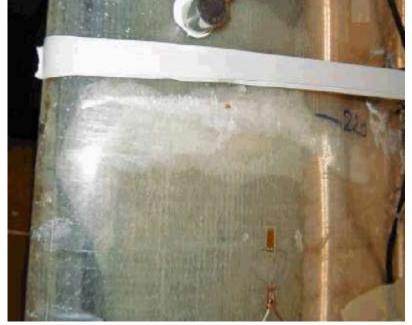
EXAMPLE: Blade 7 Static Loading to Failure

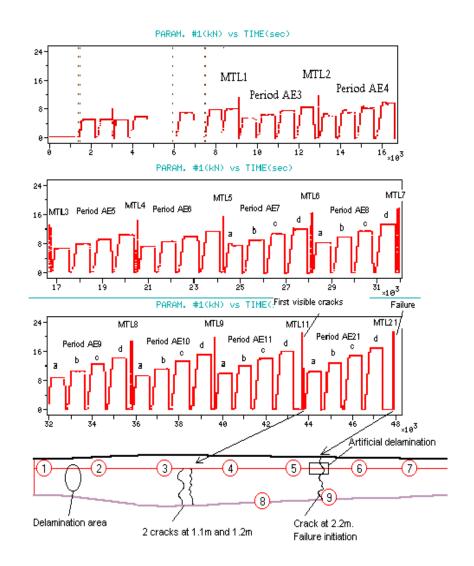
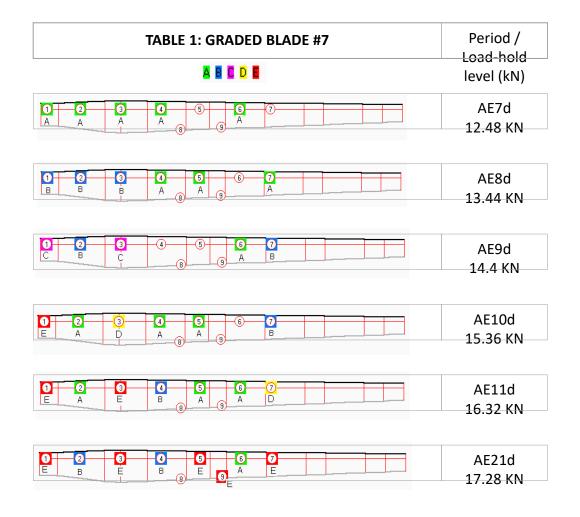
EXAMPLE: Blade 7 Static Loading to Failure - Results

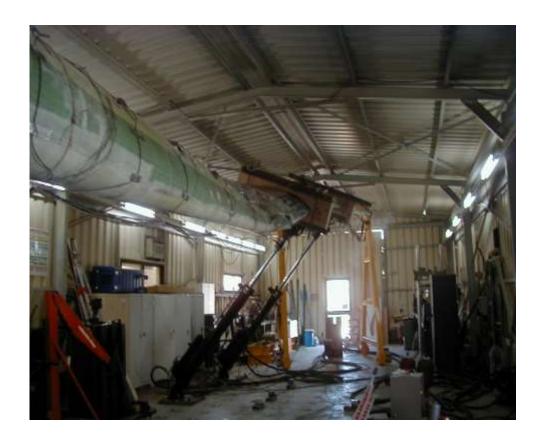
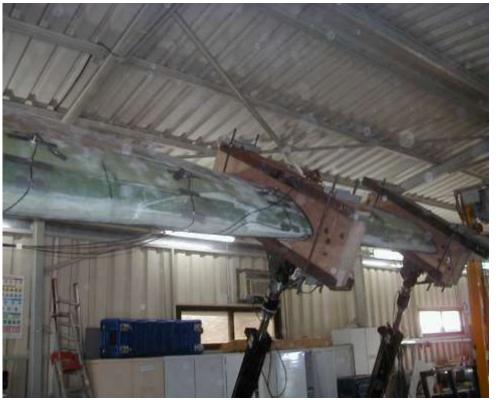
EXAMPLE: Large Blade 1 Static Loading to Failure

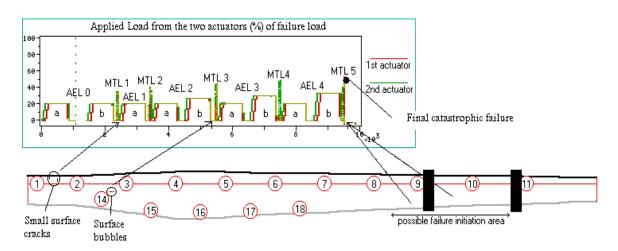
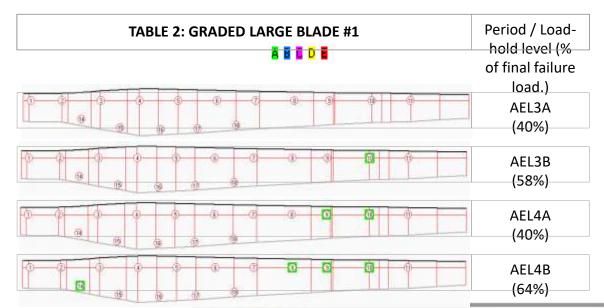
EXAMPLE: Large Blade 1 Static Loading to Failure - Results

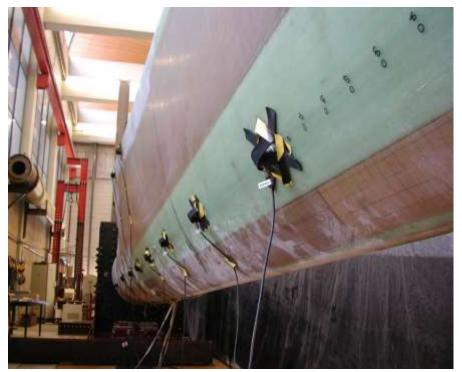
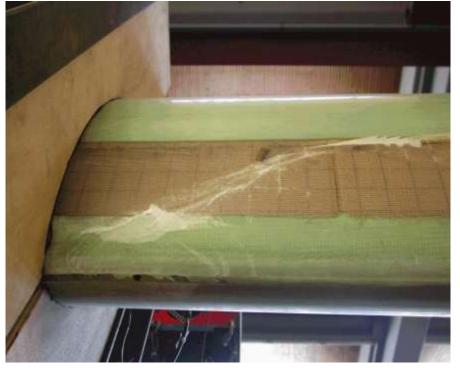
EXAMPLE: Large Blade 2 Fatigue Loading to Failure

Failure damage developed just inboard of load application point

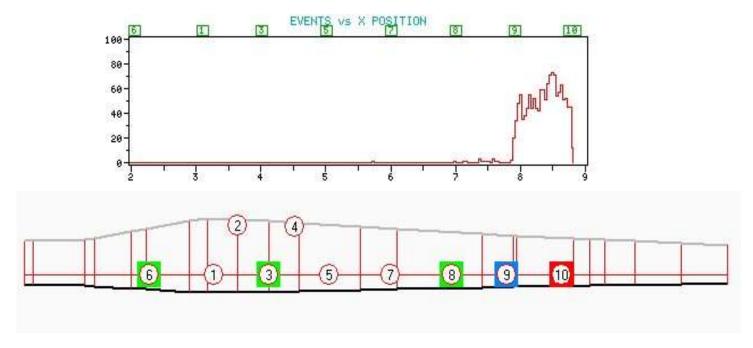
EXAMPLE: Large Blade 2 Fatigue Loading to Failure – Preliminary results

- •Linear Location results fully coincide with damaged area of the blade introduced by the fatigue test (between sensors 9 and 10)
- •Automated grading of the blade indicates that a static load to 110% of the maximum fatigue load is very severe for the blade

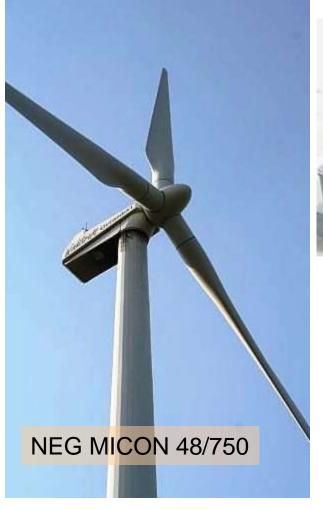
Instrumentation of an In-Service NEG MICON 48/750 at CRES wind farm in Greece using Pocket AE system – (NIMO project)

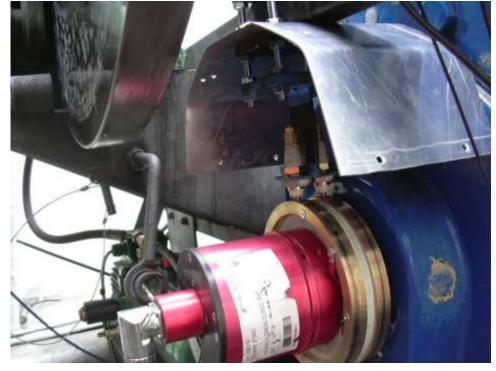
Slip-Ring installation for powering the multi-channel Micro-II AE system (NIMO Project)

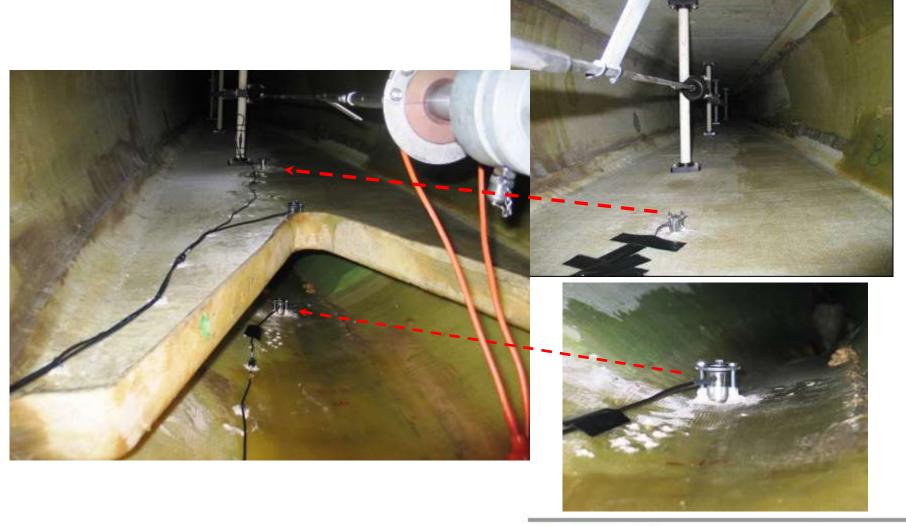
Attachment of AE Sensors on an Internal Spar of the blade and on the Trailing Side of the blade

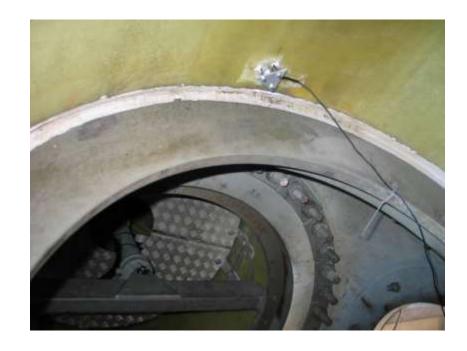
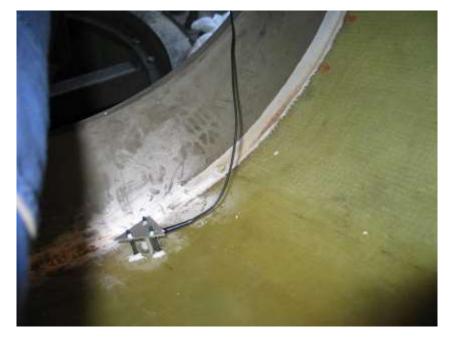
Attachment of AE sensors near blade's root

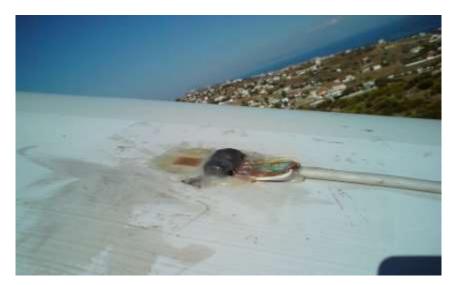
Strain Gauge attachment on the Leading Edge of the Blade

Strain Gauge Output used as a Parametric Input to the condition monitoring AE System.

What can be achieved with this parametric input:
Accurate Synchronization between the AE data acquisition and the Wind turbine operating conditions
Accurate knowledge of the blade position
Good estimation of the power produced by the W/T

Strain Gauge attachment on the Leading Edge of the Blade

Strain Gauge Output used as a Parametric input to the condition monitoring AE System.

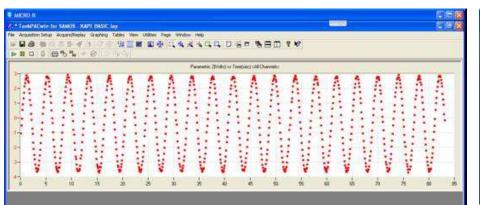
Parametric Signal Variation under Light Load & Medium Load of the W/T

Parametric Signal Variation under Light Load & Medium Load of the W/T

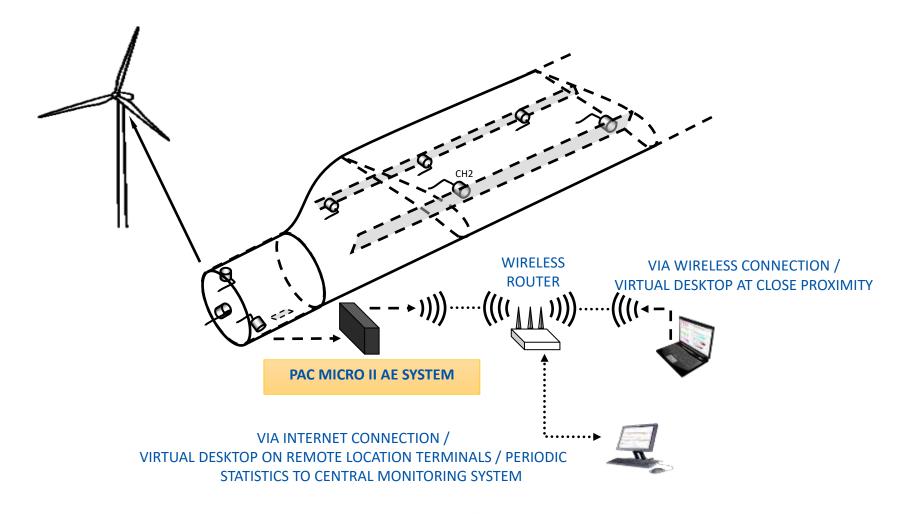
Connection to Central Monitoring System & Remote Control

VIA WIRELESS CONNECTION / VIRTUAL DESKTOP AT CLOSE PAC MICRO III.AE SYSTEM VIA INTERNET CONNECTION / VIRTUAL DESKTOP OH BEHOTE LOCATION TERMINALS / PERIODIC STATISTICS TO CENTRAL MONITORING SYSTEM MISTRAS

Connection to Central Monitoring System

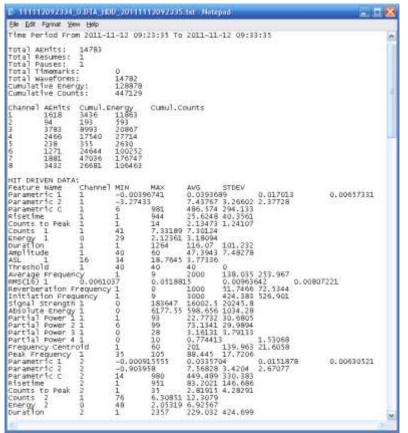
A Modified version of NOESIS LIVE was used

Generation of Real-time Statistics Automated generation and reporting of TDD and HDD data statistics to the central monitoring system or other servers. A Modified version of NOESIS LIVE was used 17% to be because of its from flat and MISTRAS

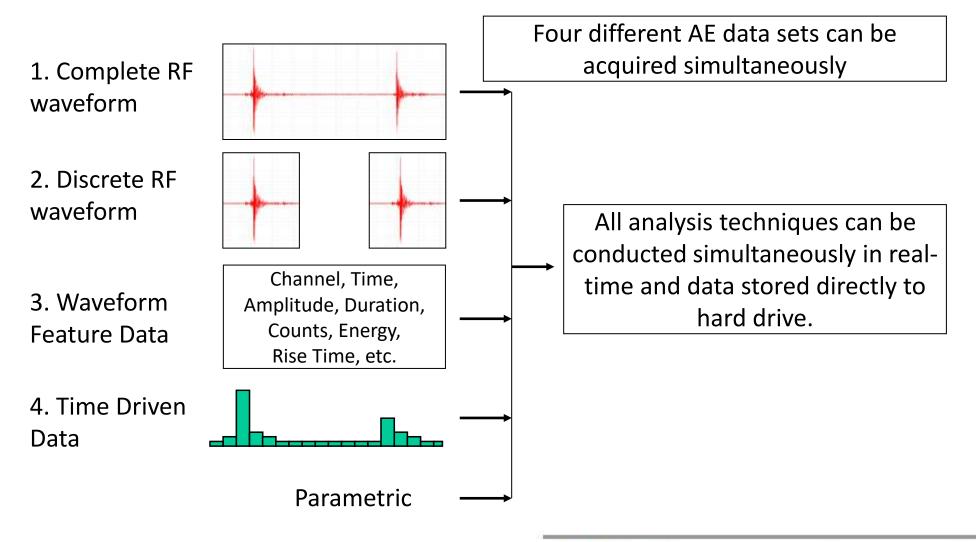
Data Analysis Principles

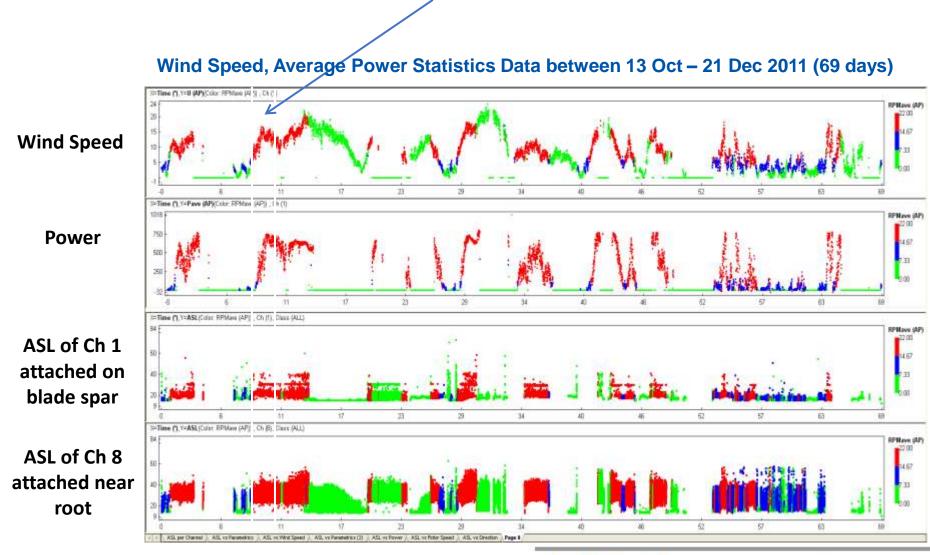
Analysis of 28 hours of AE data while wind speed was between 0 and 14 m/s (6 Beaufort)

Analysis of 28 hours of AE data while wind speed was between 0 and 14 m/s (6 Beaufort)

AE activity vs Wind Speed on background plot

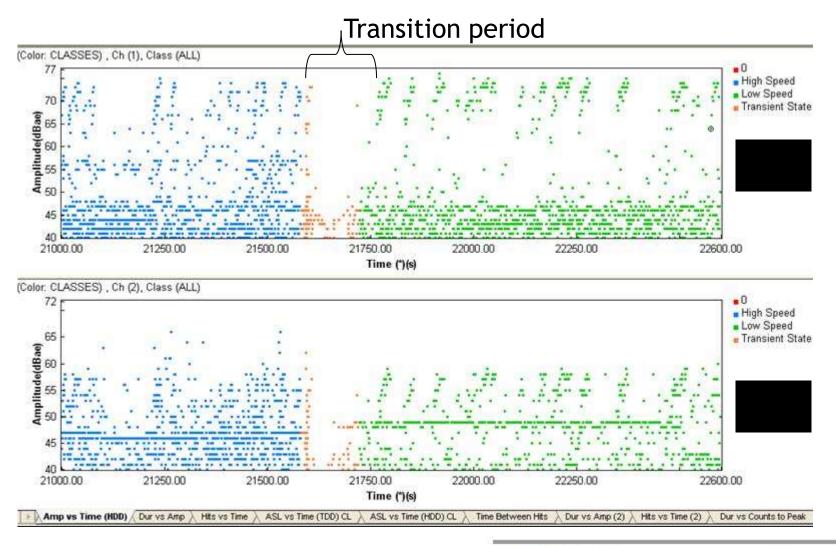
Amplitude of AE events during transition of Rotor speed from High speed to Low speed

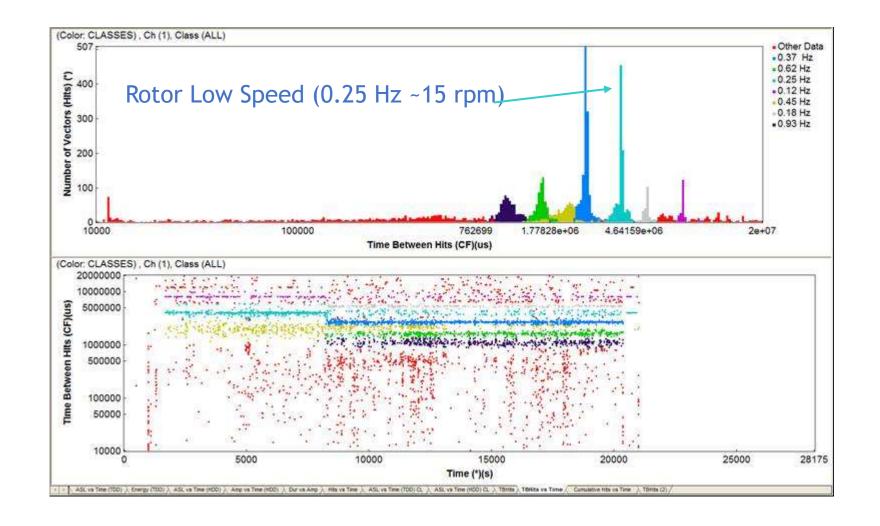
Advanced Analysis of AE Data

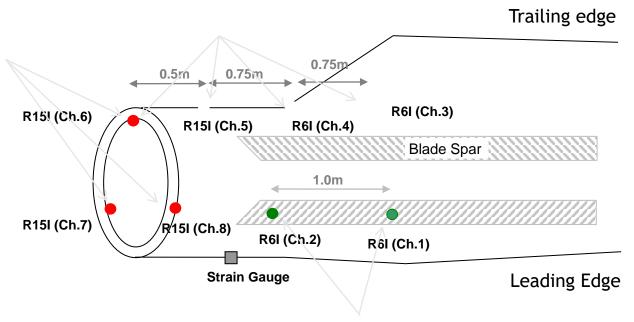
Linear Location Groups

8 AE Sensors Installed:

3 AE sensors near blade's root

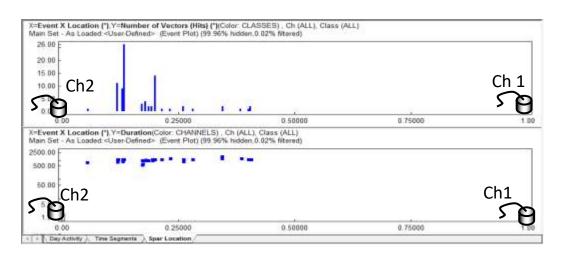
Linear Located AE Events on Blade Spar (Channels 1 & 2)

The number of located AE events & the comparison of their signatures with simulated sources signatures indicate that there is no obvious active damage mechanism under current operating conditions

- Increased amplitudes of AE activity can be observed during machine start/stop transition periods and on high loads (above 520 kW). Located AE events were not correlated with structural degradation, as the blade appears to be in good condition.

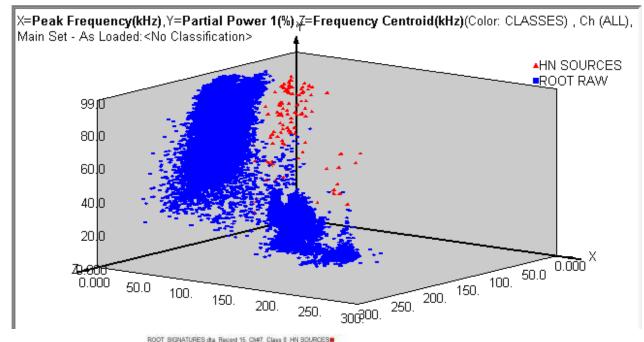
Data Separation in 3D space between raw AE activity and simulated sources recorded near blade's root

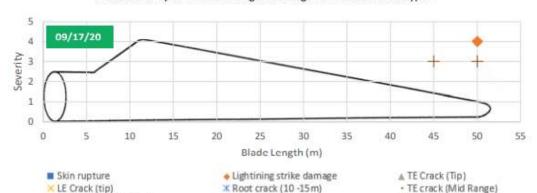
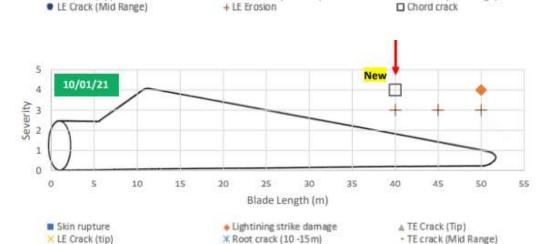
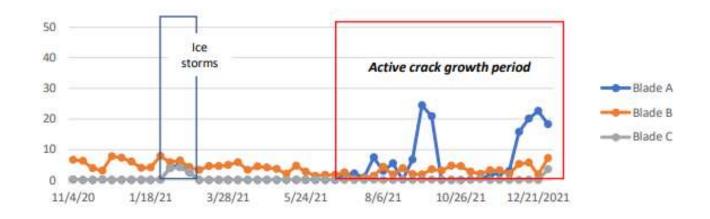
Defect severity Vs location along blade length for various defect types

+ LE Erosion

• LE Crack (Mid Range)

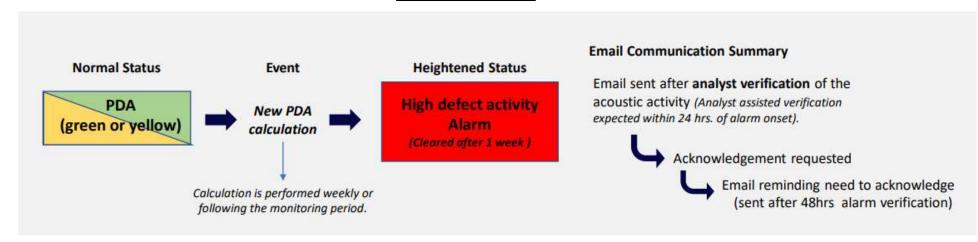
PDA Alarm

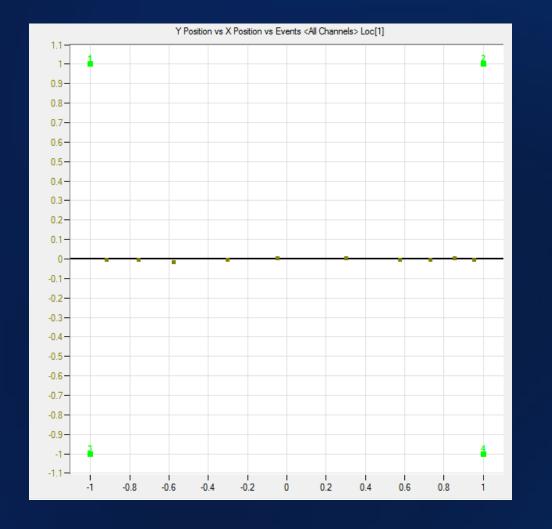
Source Location in TP Welds

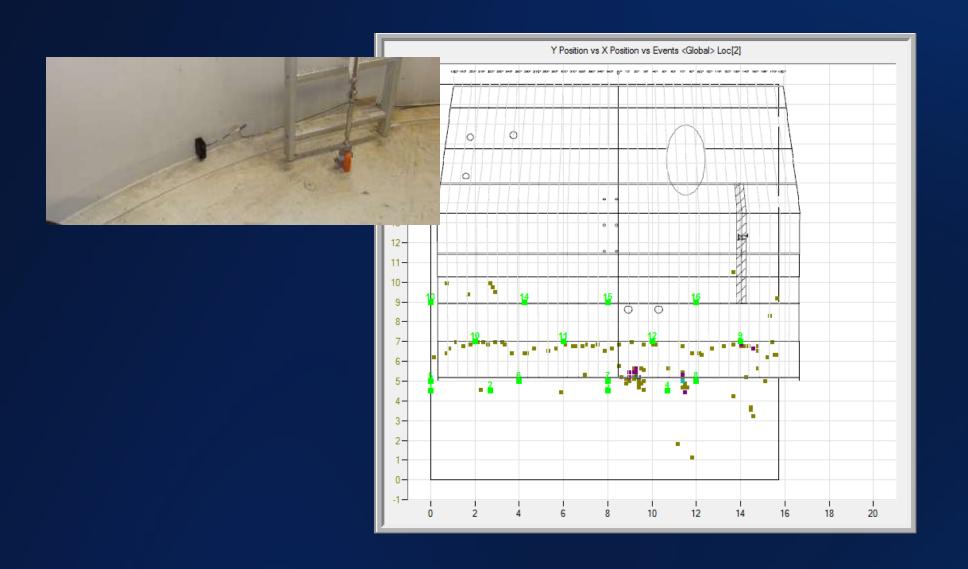
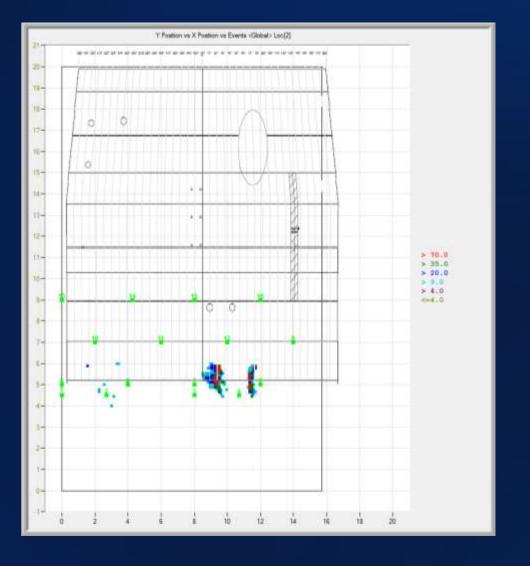
TP SUPPORTS WELD MONITORING

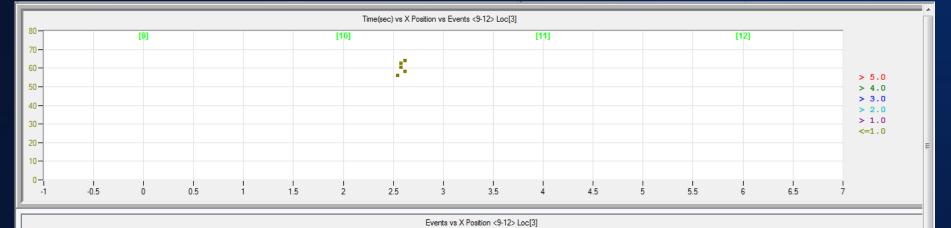
Source Location on flange

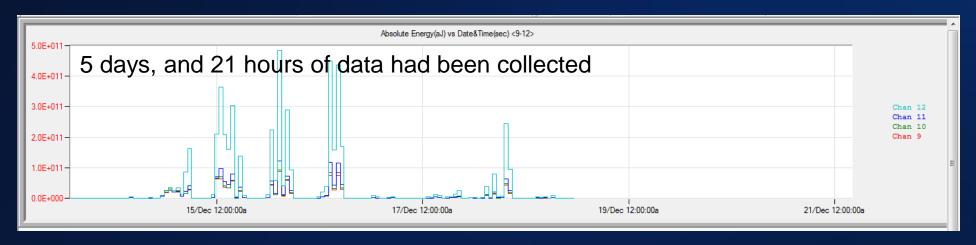
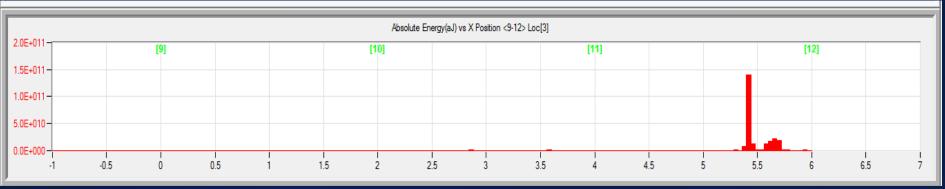
As can be seen there is no significant emission located around the defect position of 2.5m. There is an indication around 5.5m but following closer examination using guard sensors it was identified this is not located on the flange but outside and below the array
