Blade Inspection and Repair

Presenter: Theodoros Kossivas

MSc, Mechanical & Aeronautical Engineer, CompBlades founder

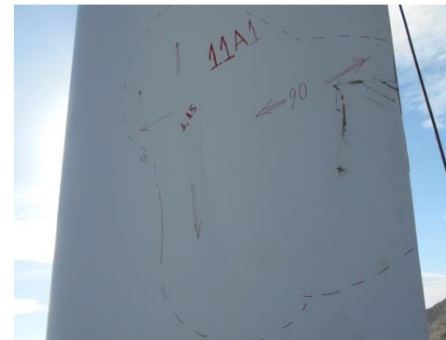
Repair 45m blade length at R25, Skins buckling (2015)

Suction side, 2m x 1m destroyed skin

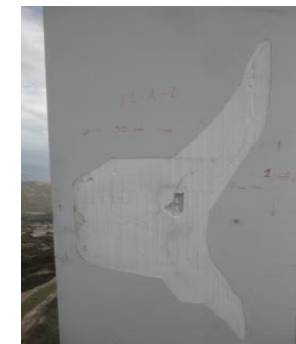
Pressure side, 1.5m x 1m destroyed skin

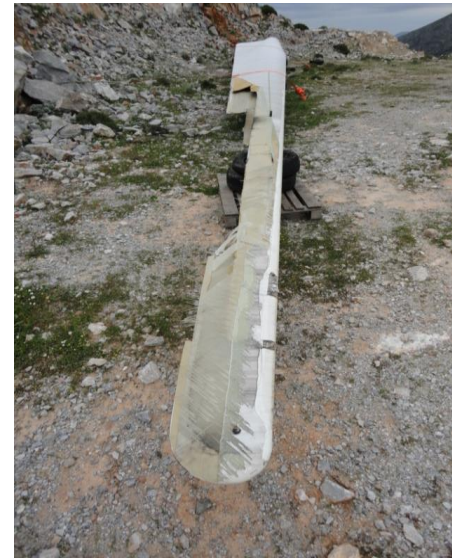
Before

10m repair on 23m blade keeping the balancing of the Reference rotor (2008)

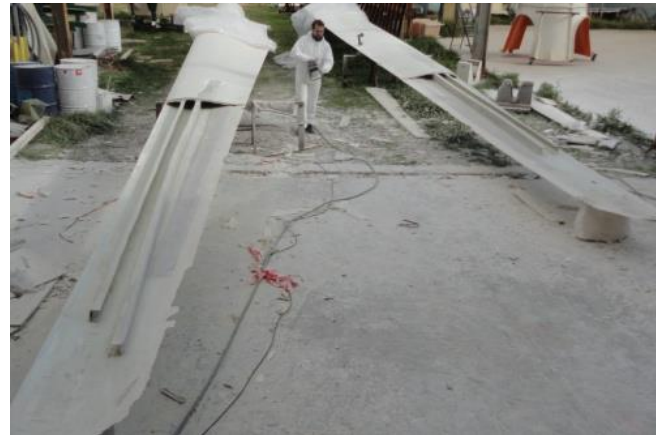
Blade reconstruction: Restoration of the blade in a 7m length.

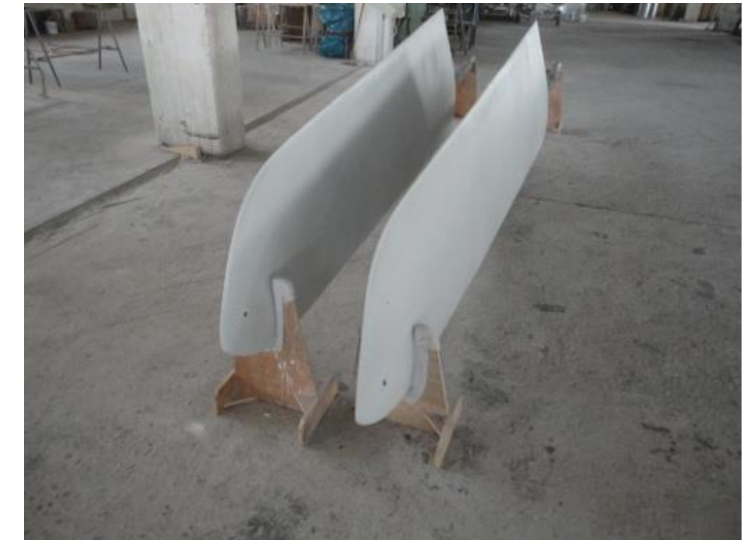
Destroyed blade tip

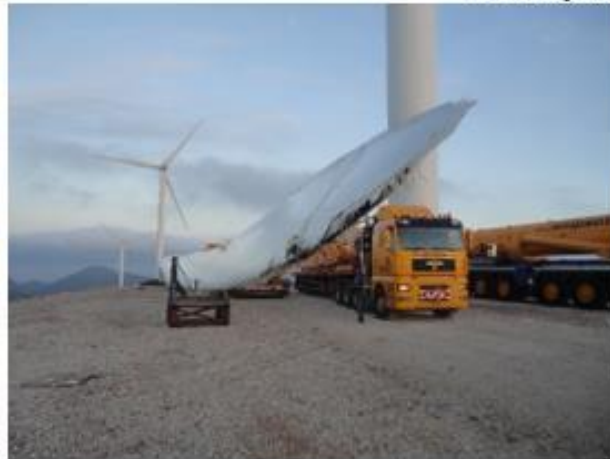
Destroyed blade on the ground

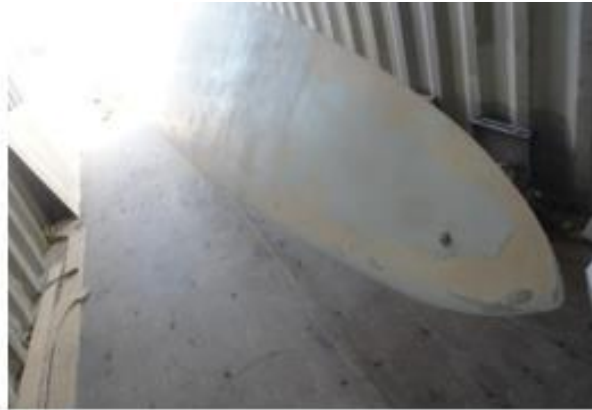
Geometry of damaged blade is recovered

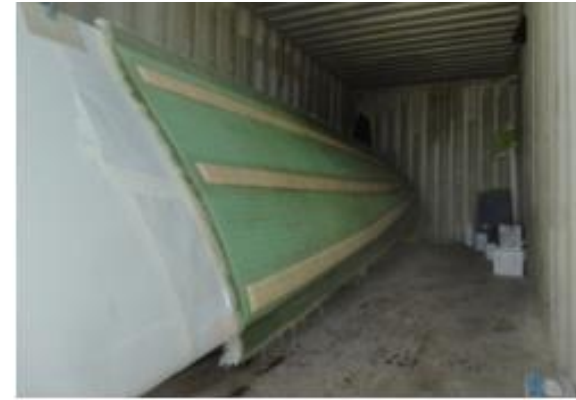
4m mold for the construction of replacement parts

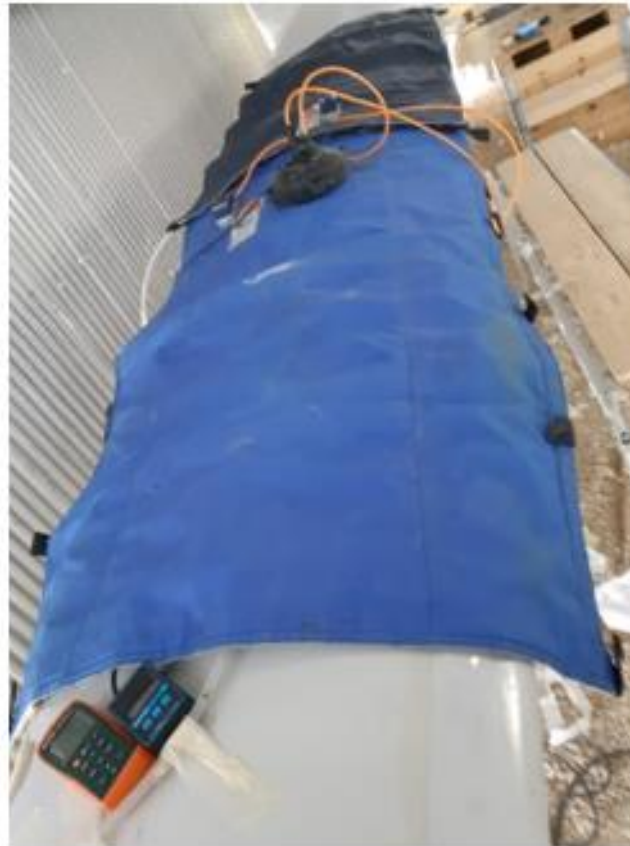
Data logger for curing program via thermocouples and vacuum pressure

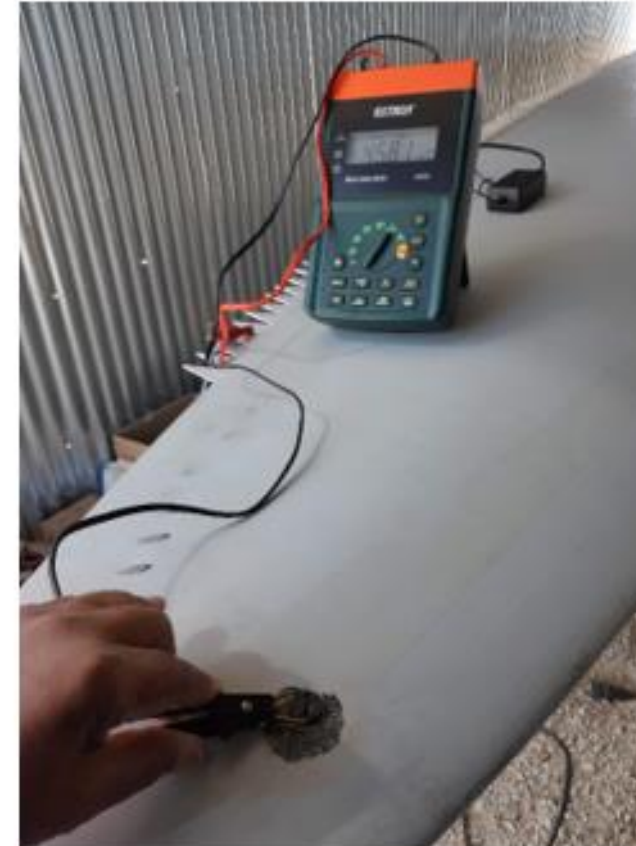
Lightning protection system (LPS), measurement of electrical resistance ($m\Omega s$)

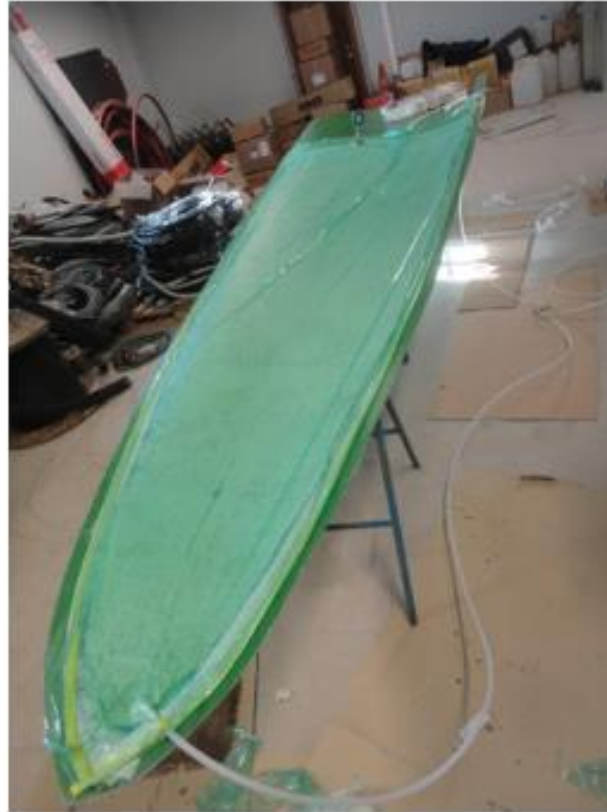
Replacement parts construction via vacuum bagging

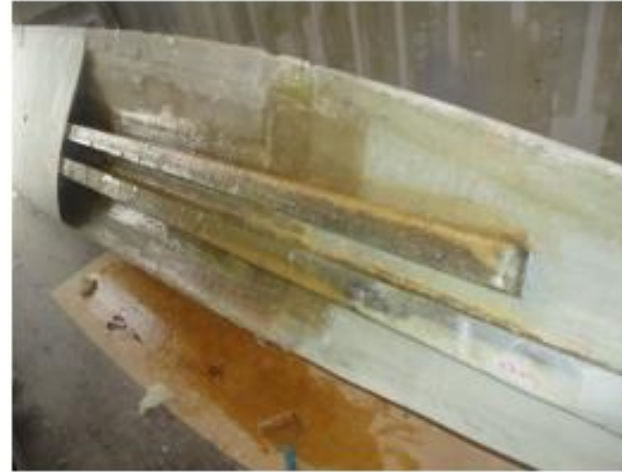
Assembly of pressure skin

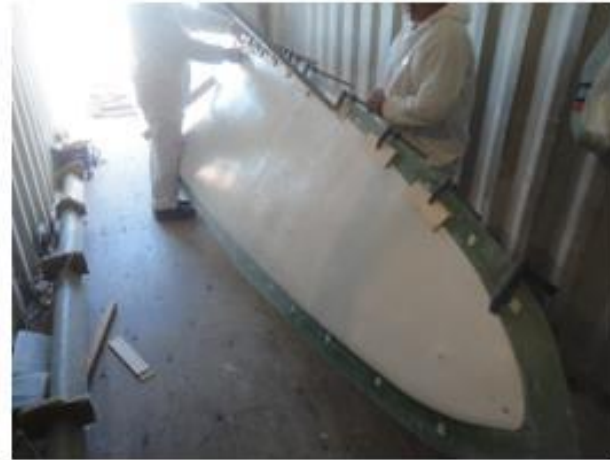
Assembly of suction skin

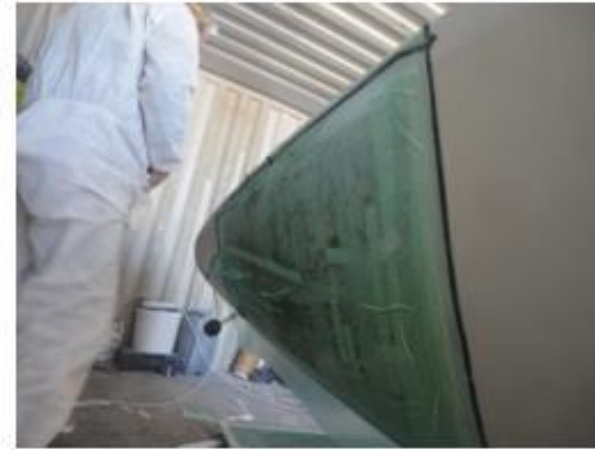
Overlapping stage

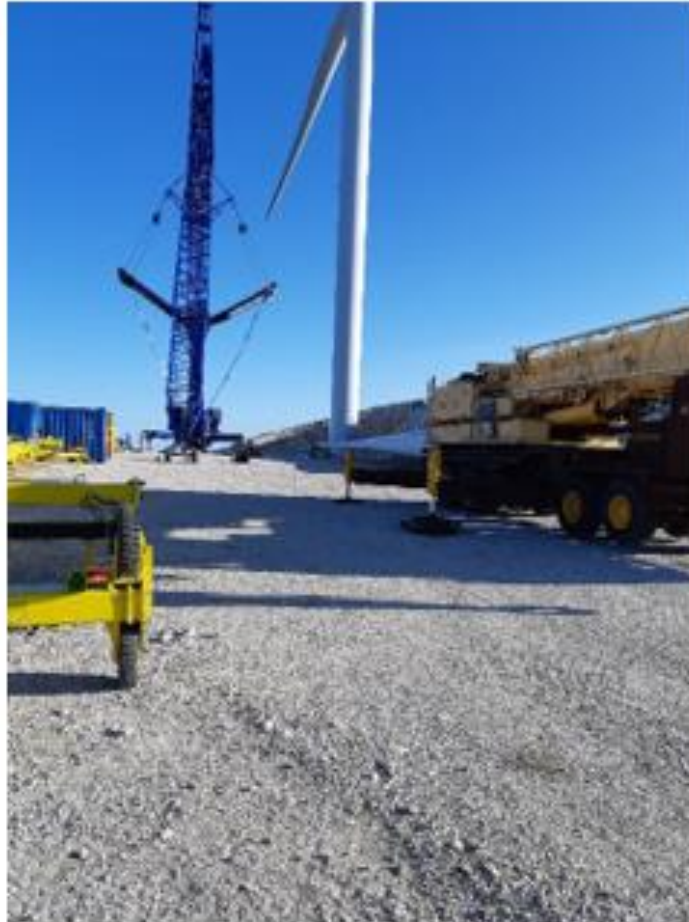
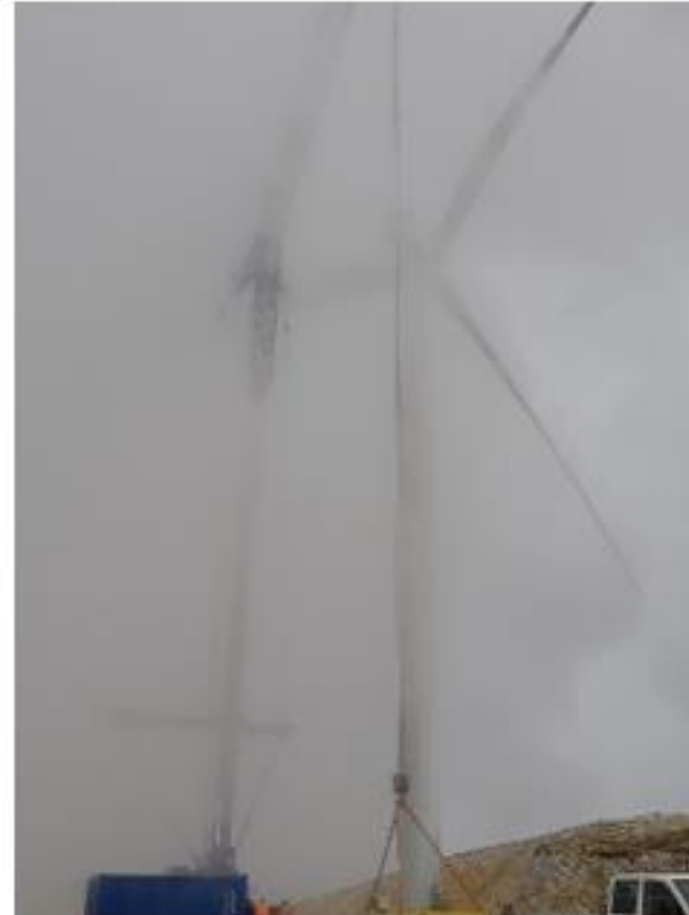
Difficult weather conditions for blade de-assembly
